Case Study

LM Serves a Canadian Ferry

A comprehensive
and transparent analysis
to find the anomaly

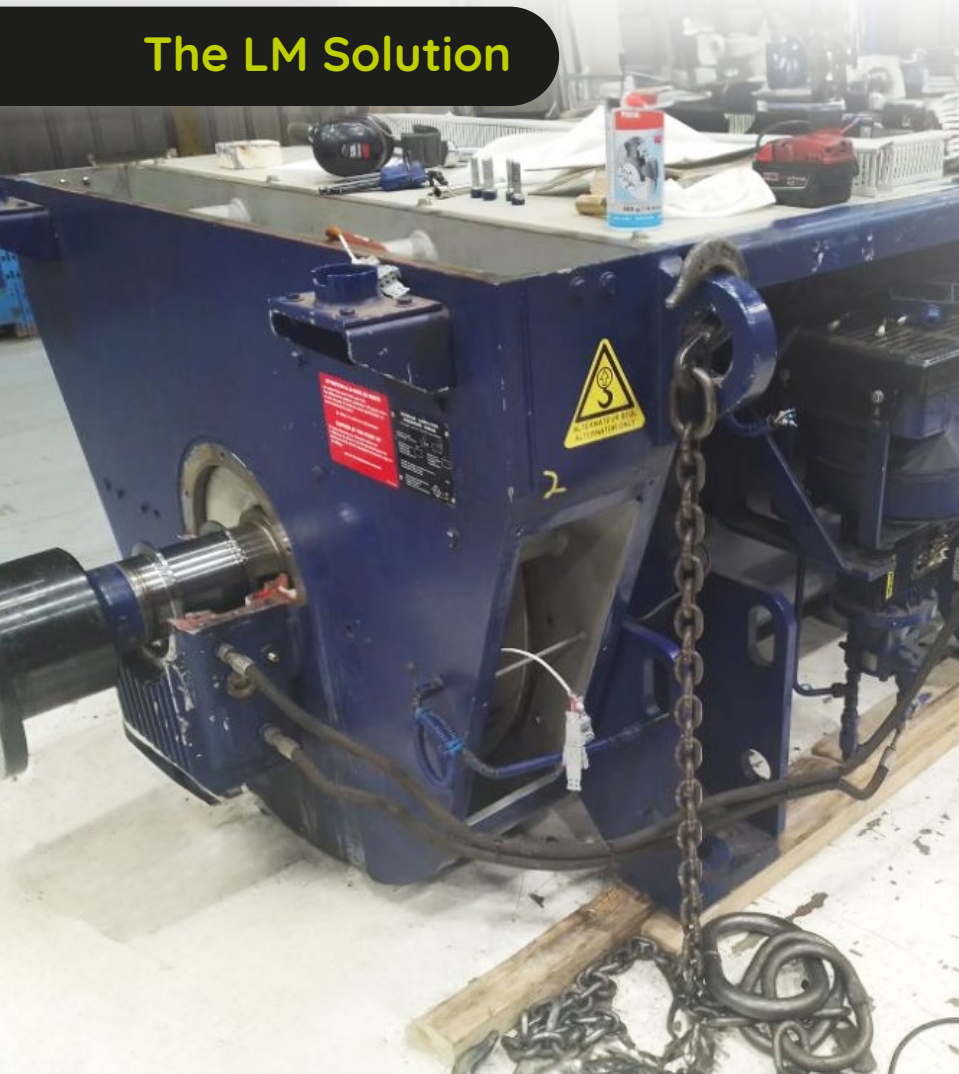
Although the generator was not directly at fault, the LM team identified overheating in the exciter rotor after electrical testing. Our failure report concluded:

» Recommendation for precision

rewinding: LM rewound the exciter rotor to prevent any future electrical failures.

The diodes were replaced with original parts supplied by the alternator manufacturer and checked before being installed on the alternator.
